### **Validating the techno-economic viability of hemp lime construction for passive and low energy moisture control in museum storage**

A thesis submitted for the degree of Doctor of Philosophy

University of Bath

Department of Architecture and Civil Engineering

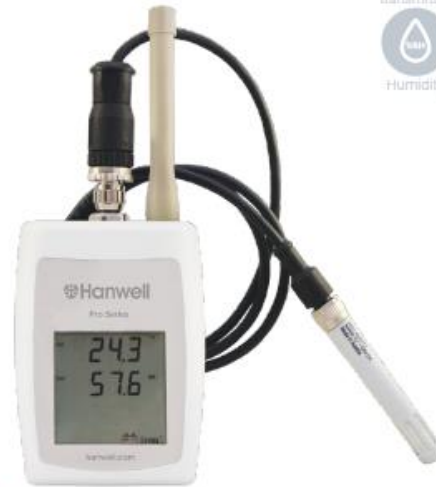
Product code: ML4114-434.075

Instrumentation specification	
Dimension (Excl. ancillaries)	110 x 80 x 35mm
Weight	200 grams
Power supply	1 x 3.6V AA Lithium battery
Case material	ABS & PC
Memory capacity	50,000 readings per channel (unit will wrap when full)
Clock accuracy (logging)	20 ppm at 25°C
IP Rating	IP30
Instrument operating range	-20°C to +65°C in a non-condensing RH environment
Storage temperature	-40°C to +60°C
Resolution	0.1°C (temp), 0.1%RH (humidity)

Radio transmitter functions	
Frequency options	A range of frequencies are available between 433-458MHz. Country specific regulations apply.
Radio power	10mW
Radio range	3km over open ground
Battery life	Up to 2 years (dependent on conditions of use and instrument settings)
Software required	W900 – Standard EMS Software Package *See EMS datasheet for further options
Hardware required	CR2 / CR3 – Controller SR2 – Smart Receiver REP – Repeater
Accessories	
Y119	Wall mounting bracket
88706	AA Lithium battery
Y421-3	EE Probe extension lead 3 meters
Y421-5	EE Probe extension lead 5 meters

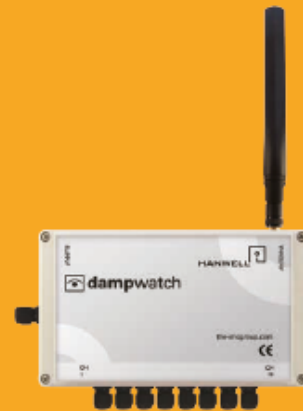
The Hanwell DampWatch unit can be used to detect this moisture well before long-term damage can set in.

With up to 16 dampness sensors per unit, DampWatch uses Wood Moisture Equivalent (WME) measurements to detect moisture in multiple areas.

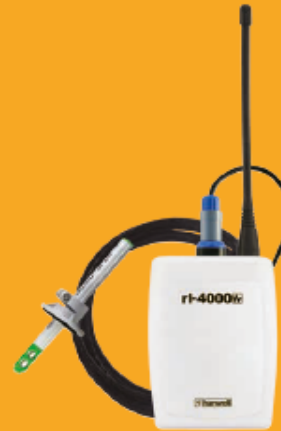
The Hanwell RL4810 wirelessly transmits directly to a local SR2/CR2 and PC or Network for immediate alarm notification and long-term analysis. This wireless device also includes a logging function that guarantees against gaps in data during the unlikely event of radio communication loss.

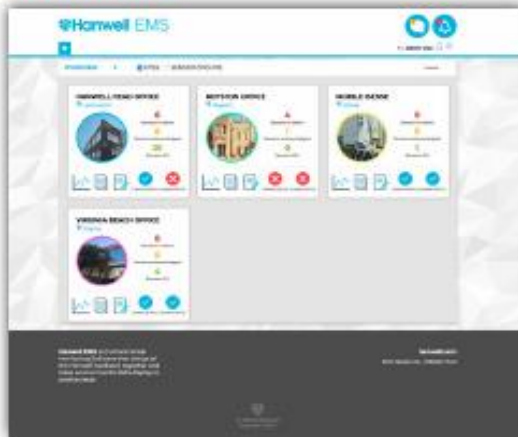
## OVERVIEW

**Overview** provides users with an overview of overall system status, while the dashboard can be customised per user.

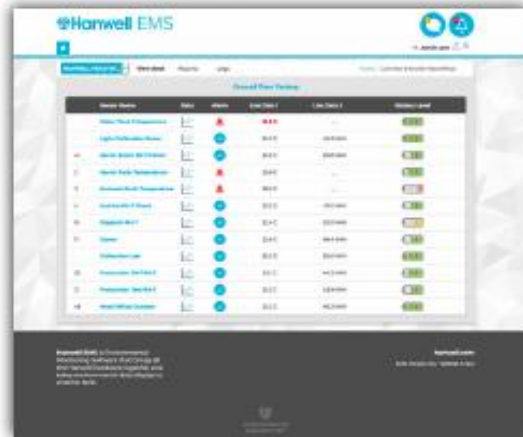
## TABULAR VIEW

**Tabular View** provides list of sensors with clear indication of alarm, battery status and live data

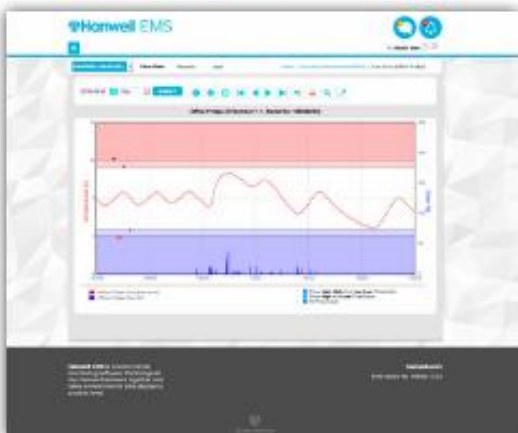
## GRAPHICAL VIEW

**Graphical View** provides line graphs with optional door position indicator, alarm level indication. Data overlays, zoom plus many more features.

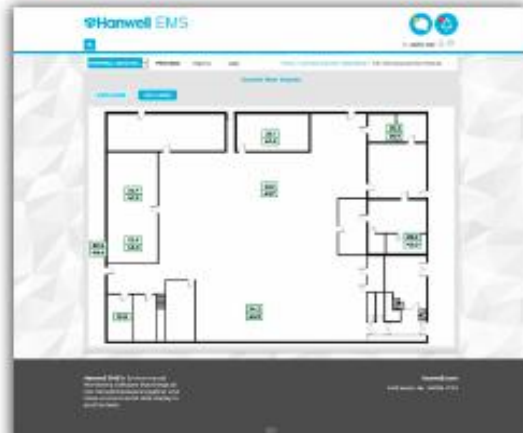
## PLAN VIEW

**Plan View** provides visual indication of sensor location within a facility. Sensor icons show real-time data and alarms and interaction by double clicking icon.

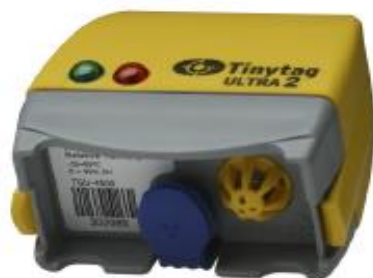
## Tinytag Ultra 2 Temperature/Relative Humidity Logger (-25 to +85 °C/0 to 95% RH)

#### Features

- Temperature and relative humidity recorder
- 32,000 reading capacity
- High accuracy
- High reading resolution
- Fast data offload
- Splash-proof case
- Low battery monitor
- User-replaceable battery
